## **Limited Good Faith Inspection**

**Concourse B Roof Replacement Project (U00245)**  
**Seattle-Tacoma International Airport**  
**17801 International Blvd, Seattle, WA 98158**

A limited “good faith” inspection of the Concourse B roof was performed to support the Concourse B Roof Replacement Project (WP# U00245). The current inspection was performed by Port Construction Services (PCS). Results are summarized below.

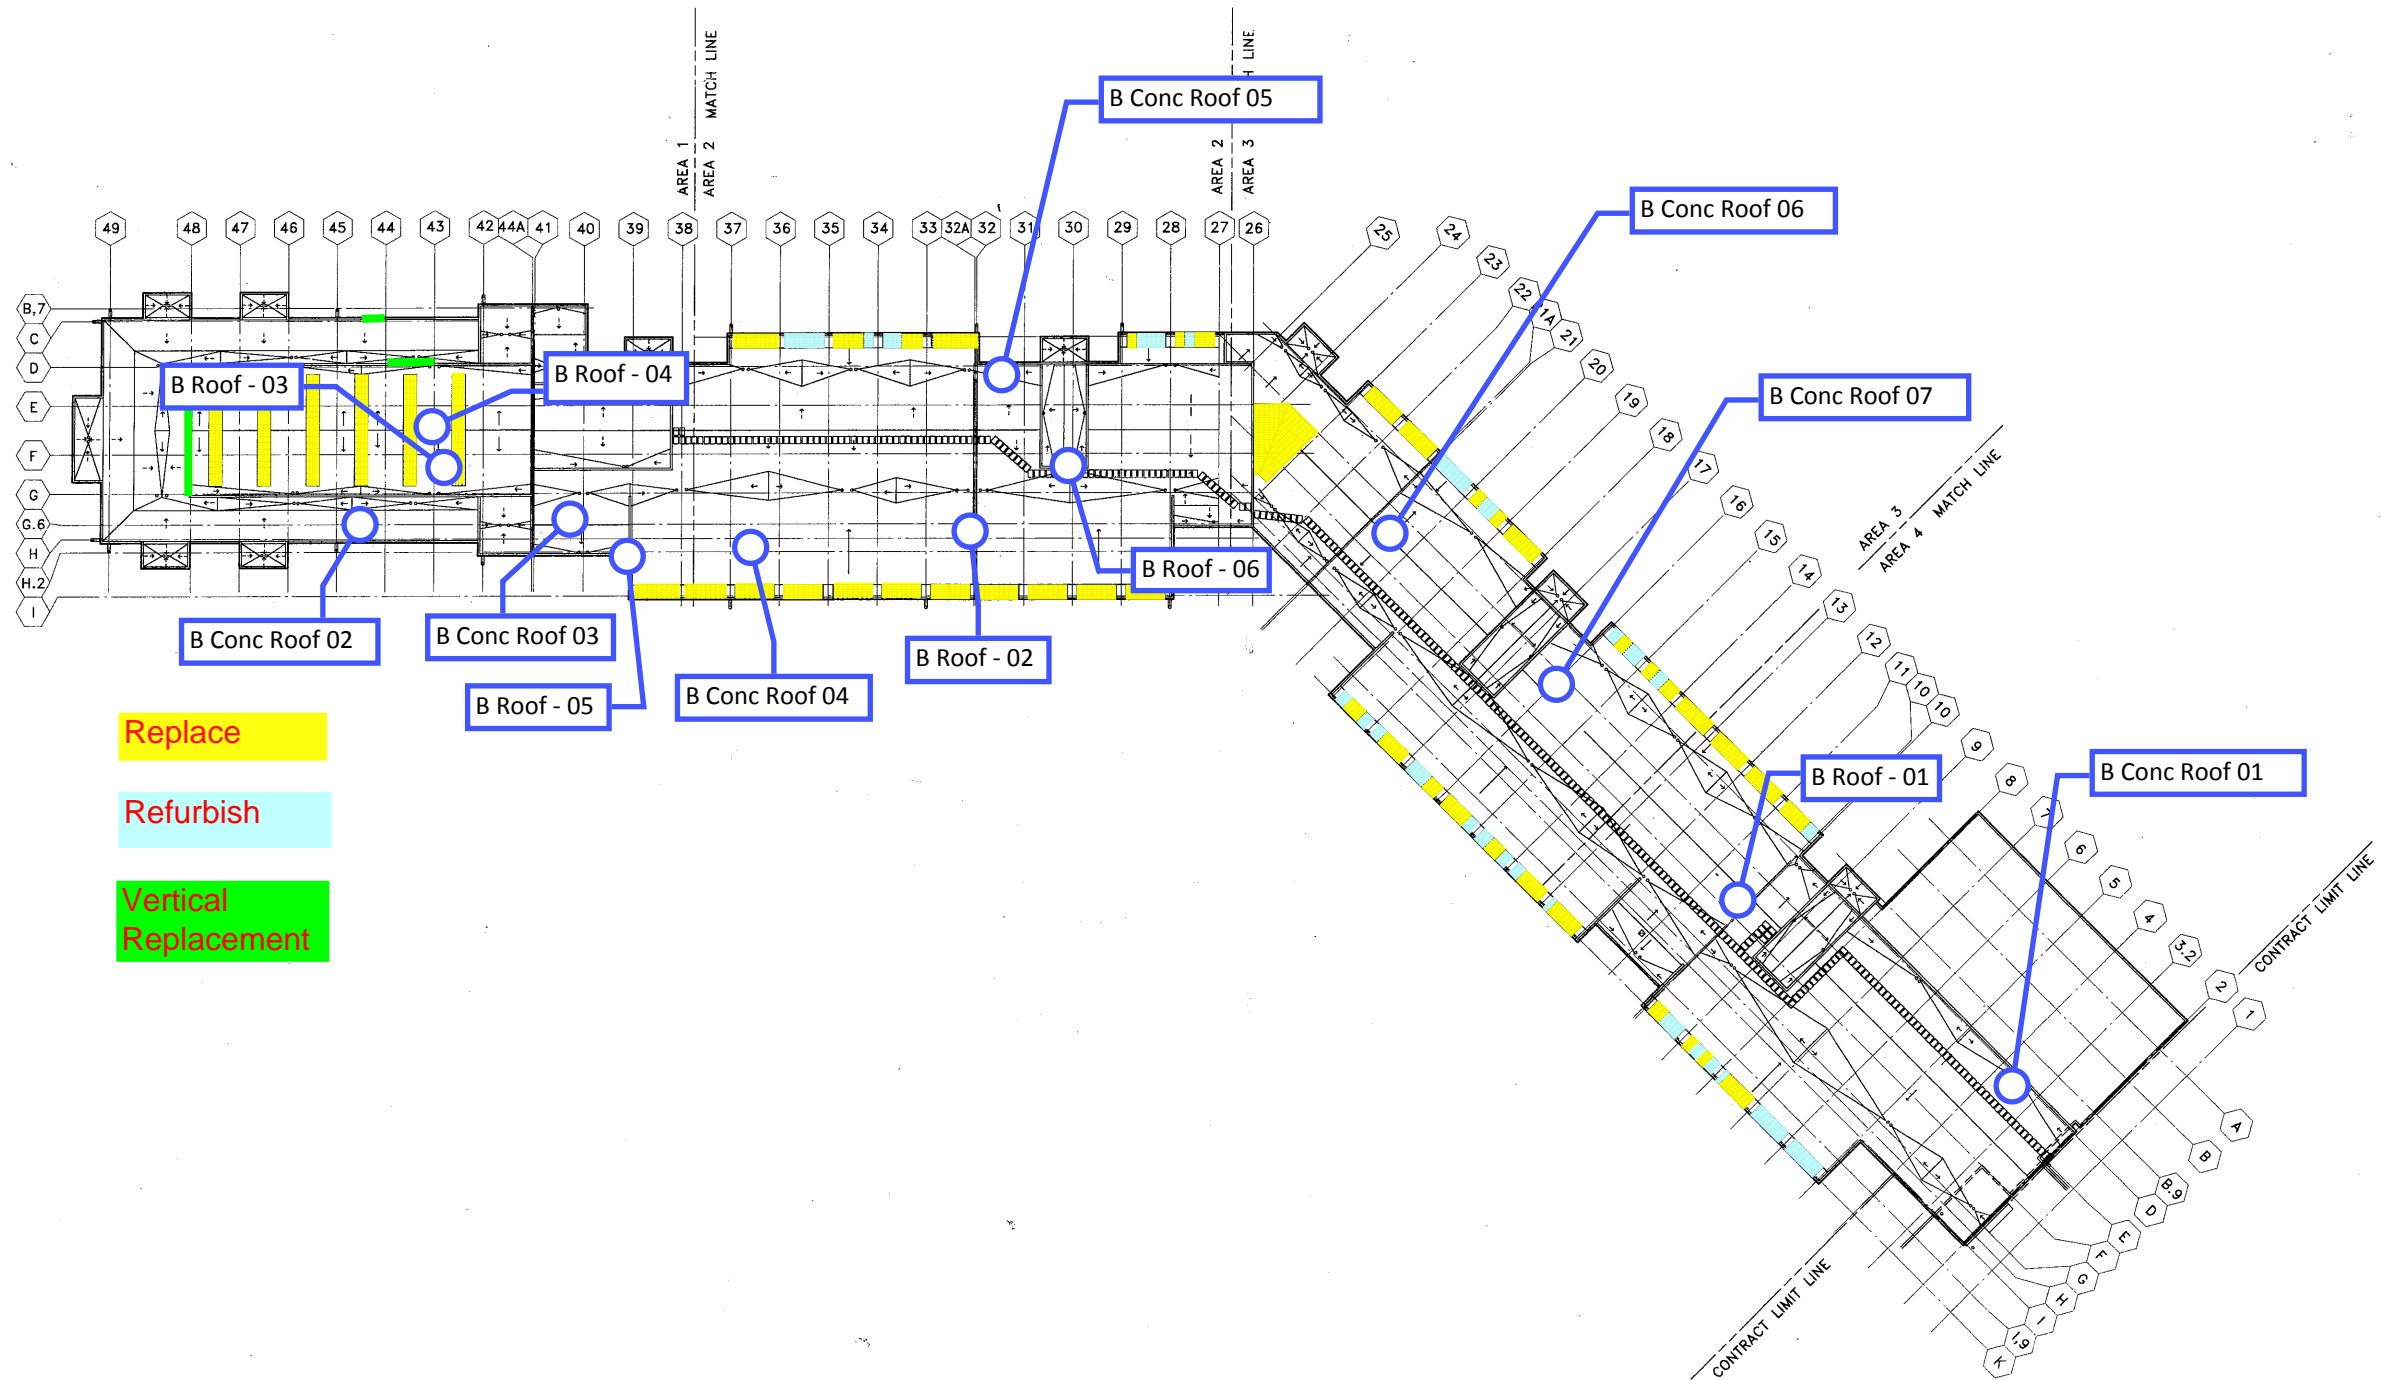
Figure 1 – Sample Locations  
Bulk Sample Analytical Reports  
Roof Index Plan  
Safety Data Sheets

Sample Number	Material	Sample Location	Lab Result
B Roof- 01	Roof sealant	Concourse B roof, grid line 10-F	ND
B Roof-02	Roof sealant	Concourse B roof, grid line 10-G.6	ND
B Roof-03	Window sealant	Concourse B roof, skylights at end of concourse, grid line 42.5-G	ND
B Roof-04	Window sealant	Concourse B roof, skylights at end of concourse, grid line 43.5-E.5	ND
B Roof-05	Exhaust vent sealant	Concourse B roof, grid line 39-H	ND
B Roof-06	Roof sealant	Concourse B roof, grid line 30-F	ND
B Conc Roof 01	Layer 1: PVC roof membrane Layer 2: Rigid foam insulation Layer 3: Lightweight insulating concrete fill	Concourse B roof, grid line 5-F	Layer 1: ND Layer 2: ND Layer 3: ND
B Conc Roof 02	Layer 1: PVC roof membrane Layer 2: Lightweight insulating concrete fill	Concourse B roof, grid line 44-H	Layer 1: ND Layer 2: ND
B Conc Roof 03	Lightweight insulating concrete fill	Concourse B roof, grid line 39-H.2	ND
B Conc Roof 04	Layer 1: PVC roof membrane Layer 2: Lightweight insulating concrete fill	Concourse B roof, grid line 40-G	Layer 1: ND Layer 2: ND

B Conc Roof 05	Layer 1: PVC roof membrane Layer 2: Lightweight insulating concrete fill	Concourse B roof, grid line 31.5-D	Layer 1: ND Layer 2: ND
B Conc Roof 06	Lightweight insulating concrete fill	Concourse B roof, grid line 20.5-E	ND

Sample Number	Material	Sample Location	Lab Result
B Conc Roof 07	Lightweight insulating concrete fill	Concourse B roof, grid line 18-E	ND
B3PH-02	Gray spray-applied fireproofing	Concourse B, penthouse, west wall	ND
BH14-04	Gray spray-applied fireproofing (debris)	Concourse B, interstitial space, BH14	ND
BH9-06	Gray spray-applied fireproofing (debris)	Concourse B, interstitial space, BH9	ND
B-A01	Gray spray-applied fireproofing	Concourse B, Room B3263R	ND
B-A02	Gray spray-applied fireproofing	Concourse B, Room B3262R	ND
B-A03	Gray spray-applied fireproofing	Concourse B, Room B3246R	ND
B-A04	Gray spray-applied fireproofing	Concourse B, Room B3205R	ND
B-A05	Gray spray-applied fireproofing	Concourse B, outside Room B3220R	ND
B-A06	Gray spray-applied fireproofing	Concourse B, Room B3206R	ND
B-A07	Gray spray-applied fireproofing	Concourse B, outside Room B3203R	ND
