Limited Good Faith Survey

September 11, 2023

Post-IAF Airline Realignment (N00030)

Seattle-Tacoma International Airport – North Satellite

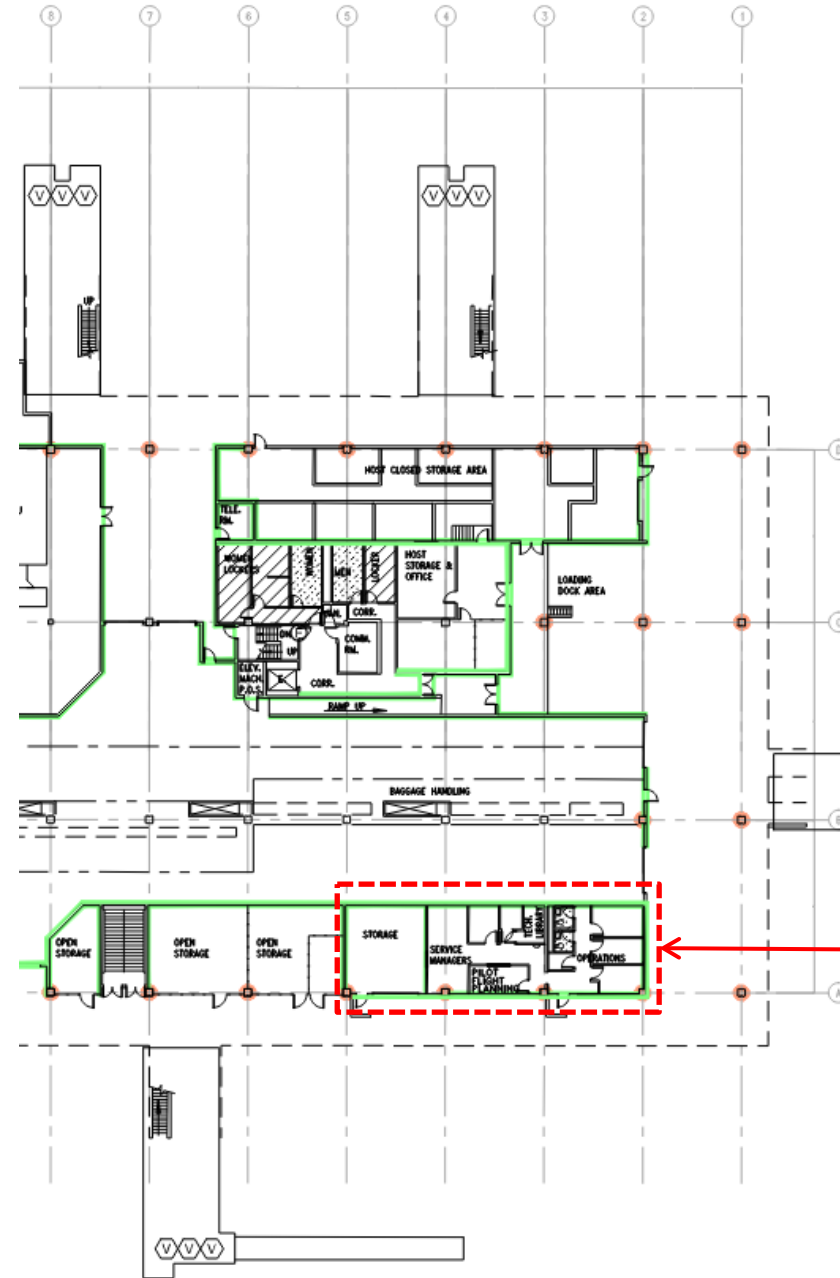
Figure 1
**South Satellite Ramp Level
Asbestos Material Locations**

Material	Material Location	Asbestos Content
South Satellite Ramp Level		
Fireproofing overspray and debris	Wall cavities in South Satellite work area See Figure 2	PACM
Block filler sealant	CMU walls in South Satellite work area See Figure 1	PACM

- GREY ASBESTOS-CONTAINING COATING/SEALANT ON PAINTED INTERIOR AND EXTERIOR CMU WALLS
HSA IDS: R31, R32
- GREY ASBESTOS-CONTAINING COATING/SEALANT ON CONCRETE STRUCTURAL COLUMNS (INTERIOR AND EXTERIOR SIDES IN MOST PLACES)
HSA ID: R38

- P METAL AND WOOD-CLAD FIRE DOORS (ASSUMED ACM)
HSA ID: R45
- 12" x 12" ASBESTOS-CONTAINING BROWN VINYL FLOOR TILES AND BLACK ASBESTOS-CONTAINING MASTIC (TILE AND MASTIC)
HSA ID: R47

- F GREY ASBESTOS-CONTAINING SEALANT AT FLANGE SEAMS OF LARGE AIR HANDLING UNIT
HSA ID: R55
- BLACK ASBESTOS-CONTAINING MASTIC BEHIND NON-ACM RUBBER COVE BASE
HSA ID: R91

- BLACK ASBESTOS-CONTAINING MASTIC BELOW NON-ACM VINYL FLOOR TILES AND CARPET
HSA ID: R103, R104
- FIREPROOFING OVERSPRAY AND DEBRIS BELOW CERAMIC TILE FLOORING IN RESTROOMS
HSA ID: R107

- V BLACK ASBESTOS-CONTAINING SEALANT ASSOCIATED WITH BOX VENTS ON BRIDGE NODE ROOFS
HSA ID: GISS-8
- ▲ GREY ASBESTOS-CONTAINING CAULKING ASSOCIATED WITH NON-ACM BLACK CAULKING AT ONE EXTERIOR OVERHANG SEAM
HSA ID: GISS-10

Asbestos-containing material (ACM) and presumed asbestos-containing material (PACM) that may be impacted by demolition/renovation activities must be removed by a licensed asbestos abatement contractor prior to disturbance. The asbestos work must be performed in compliance with Washington State worker protection and environmental protection regulations. See WAC 296-62, WAC 296-65, and Puget Sound Clean Air Agency Regulation III, Article 4 for additional information.

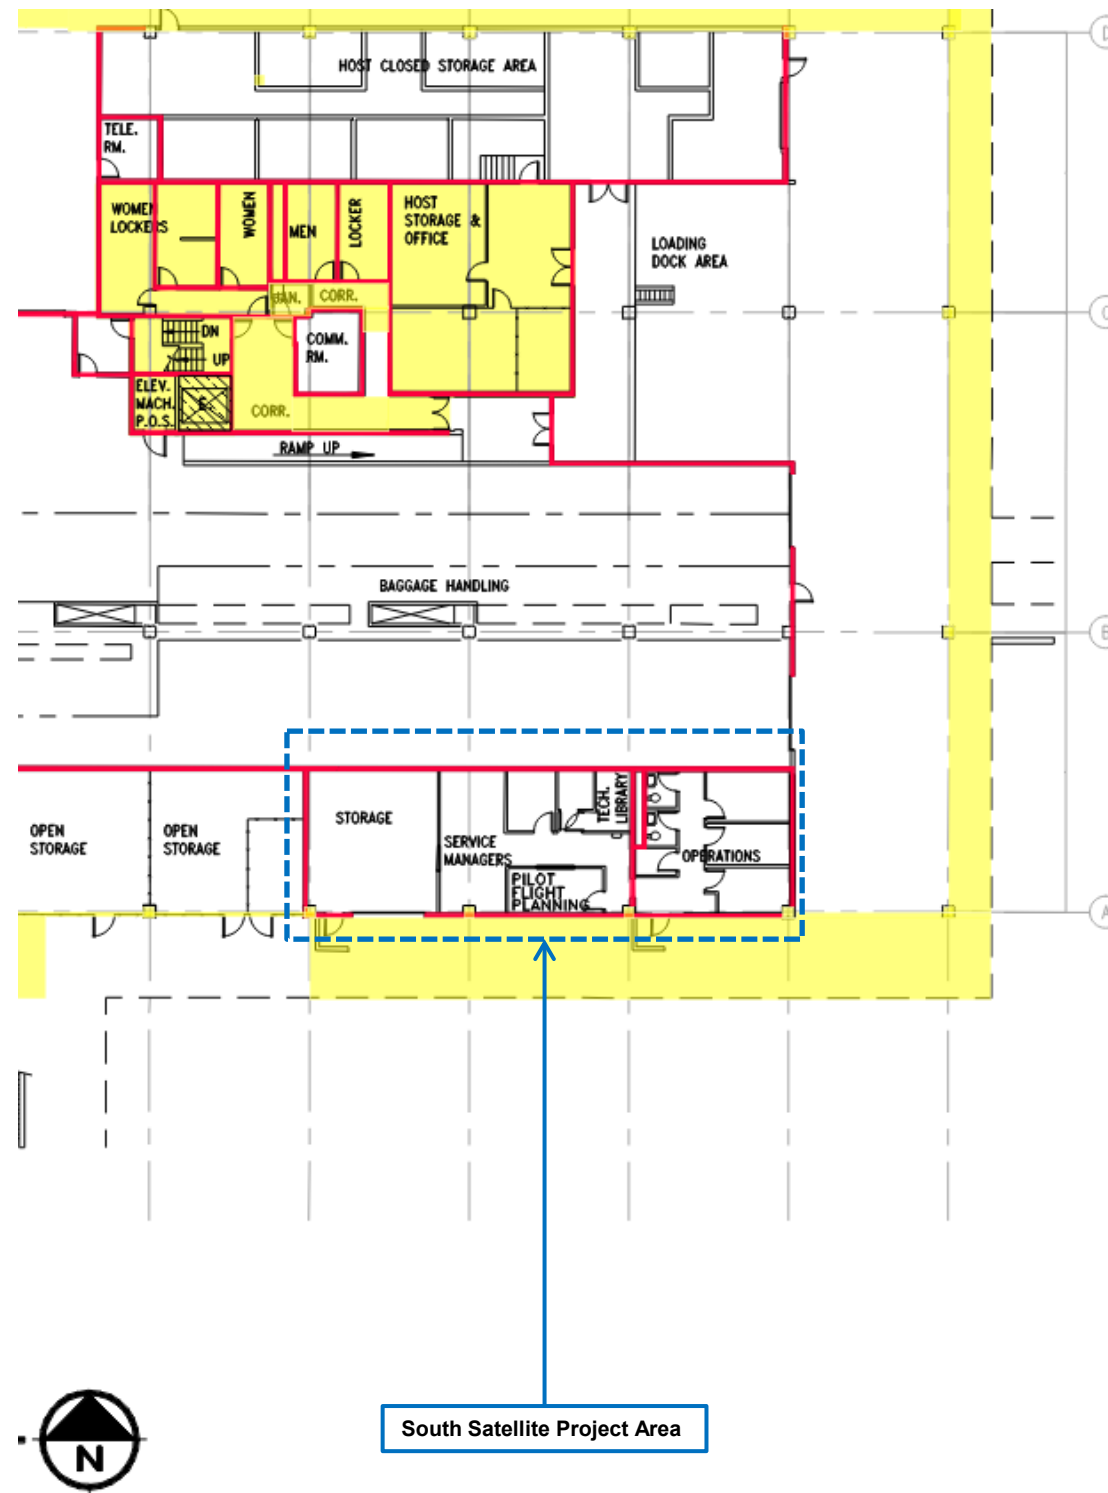
Figure 2
South Satellite Ramp Level
Asbestos Material Locations – Fireproofing

BEIGE ASBESTOS-CONTAINING SPRAY-APPLIED FIREPROOFING AND FIREPROOFING OVERSPRAY AND DEBRIS
 HSA ID: C1
 WHERE SHOWN ON DRAWING, MATERIAL IS PRESENT AT THE FOLLOWING LOCATIONS:
 - FIREPROOFING ON STRUCTURAL STEEL I-BEAMS AND CORRUGATED METAL PAN-DECKING AT CEILING OR ABOVE SUSPENDED CEILINGS AND EXTERIOR OVERHANG CEILINGS
 - OVERSPRAY AND DEBRIS ON BACKSIDE OF SUSPENDED CEILINGS, EXTERIOR OVERHANG CEILING, LIGHT FIXTURES, AND MECHANICAL AND ELECTRICAL COMPONENTS
 - OVERSPRAY AND DEBRIS IN MECHANICAL SHAFTS AND CHASES

BEIGE ASBESTOS-CONTAINING FIREPROOFING OVERSPRAY AND DEBRIS THROUGHOUT ORIGINAL GYPSUM BOARD WALL CAVITIES AND AT TOP SECTION OF CMU WALL CAVITIES; ALSO AT CEILING BETWEEN I-BEAMS AT COLUMN LINE 9 EXPANSION JOINT
 HSA ID: R107

FIREPROOFING ON BEAMS AND FIREPROOFING OVERSPRAY AND DEBRIS ON ELEVATOR HOISTWAY WALLS AND BEHIND GYPSUM WALLS LINING ELEVATOR HOISTWAY (ELEVATORS SSB AND SSC)
 HSA IDS: SSB/C-11, SSB/C-12

FIREPROOFING ON BACKSIDE OF I-BEAMS IN ELEVATOR HOISTWAY AND FIREPROOFING OVERSPRAY AND DEBRIS BEHIND GYPSUM WALLS LINING ELEVATOR SHAFT (ELEVATOR SSAF)
 HSA ID: R107

RESIDUAL ASBESTOS-CONTAINING FIREPROOFING WAS FOUND AT THIS APPROXIMATE LOCATION ASSOCIATED WITH NON-ACM SEALANT ON METAL DUCTING BEHIND NON-ACM DUCT INSULATION (DUCTING IS NEAR CEILING)
 (DUCTING IS NEAR CEILING)
 SEE SAMPLE ID: SSHVAC-R21-01

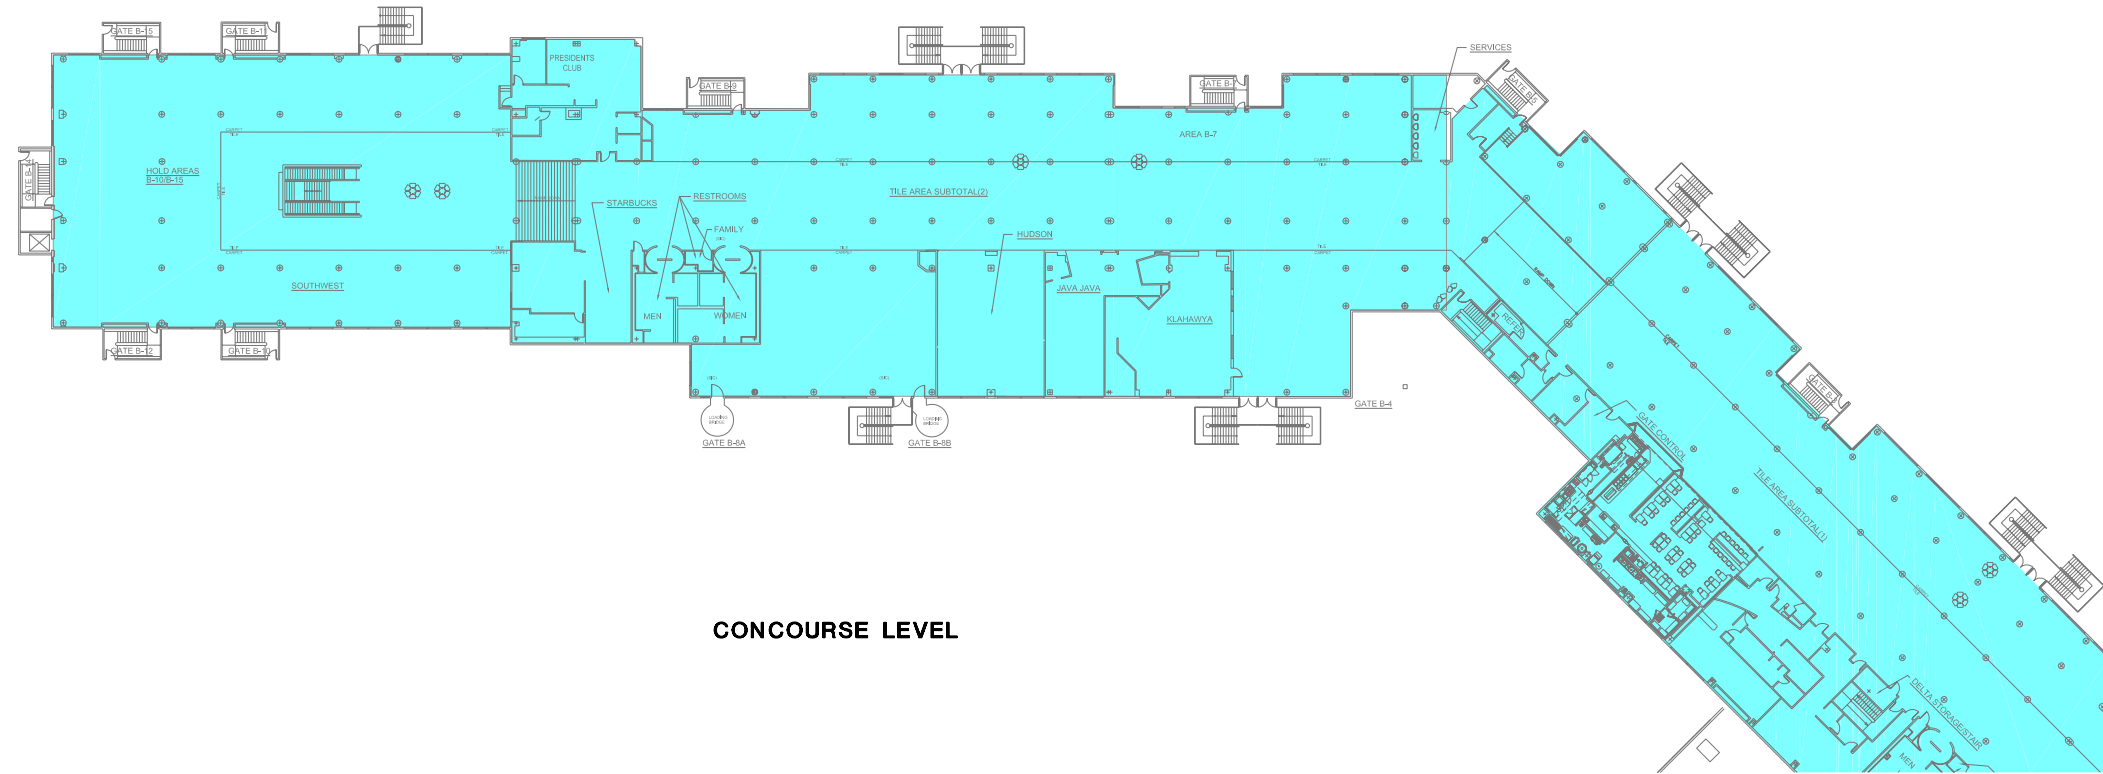
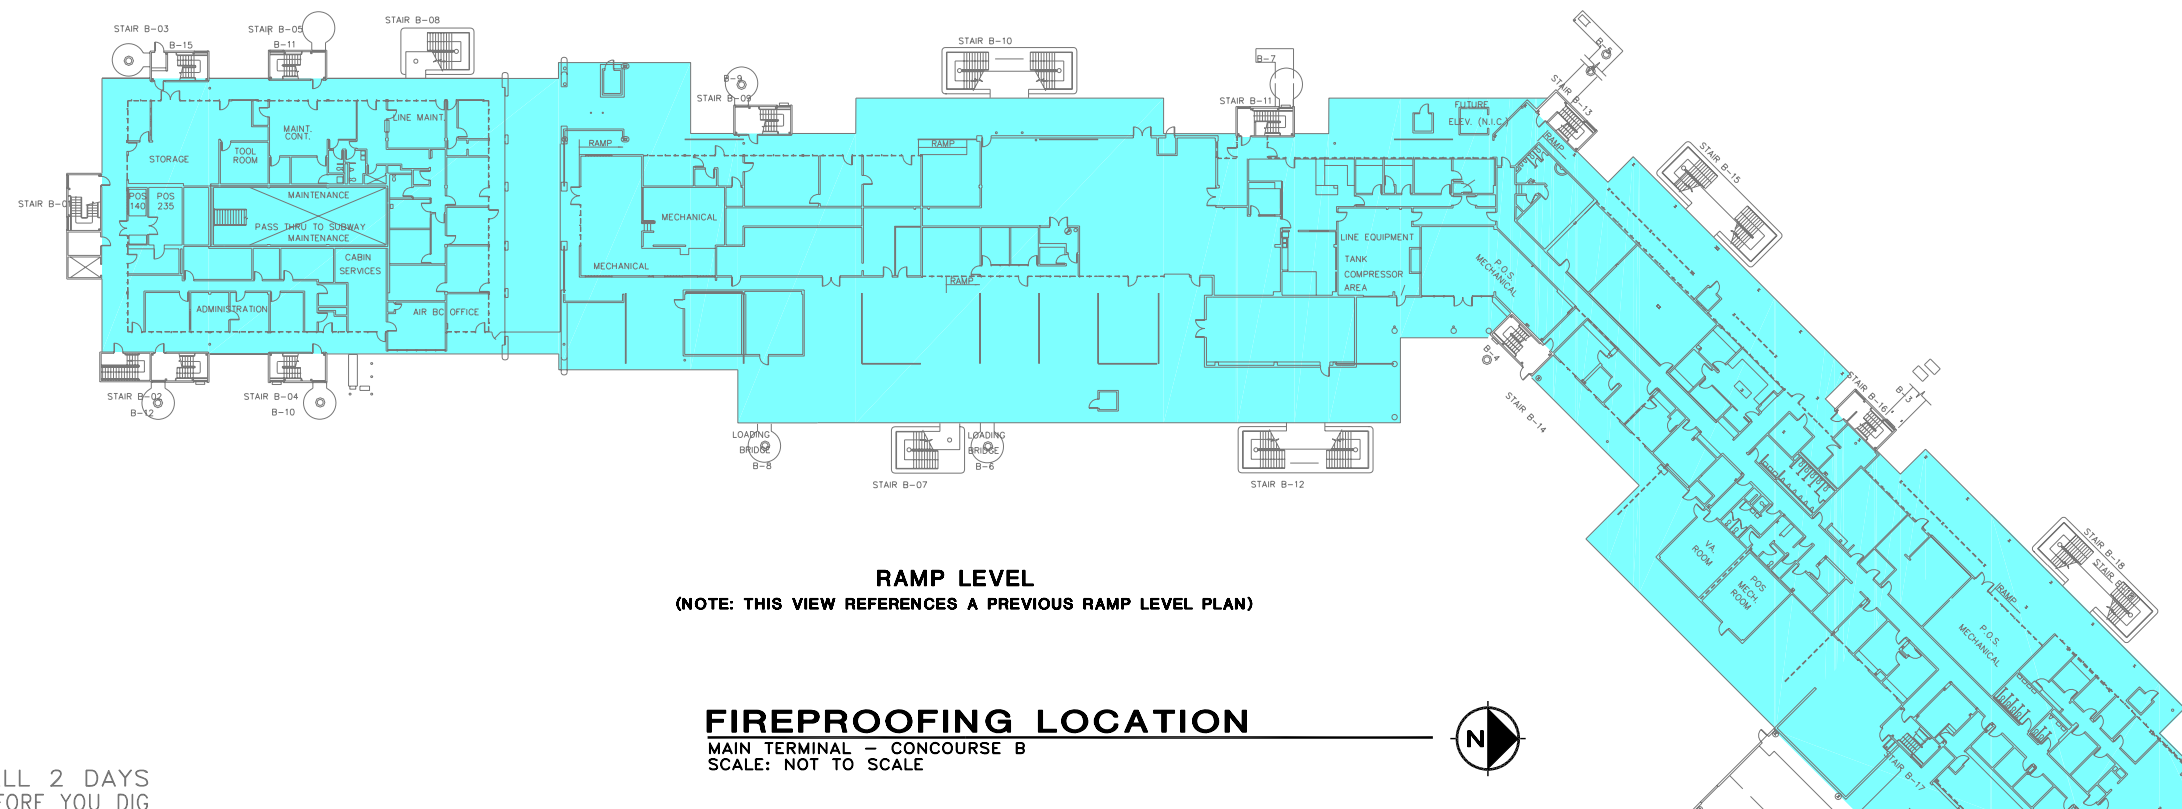
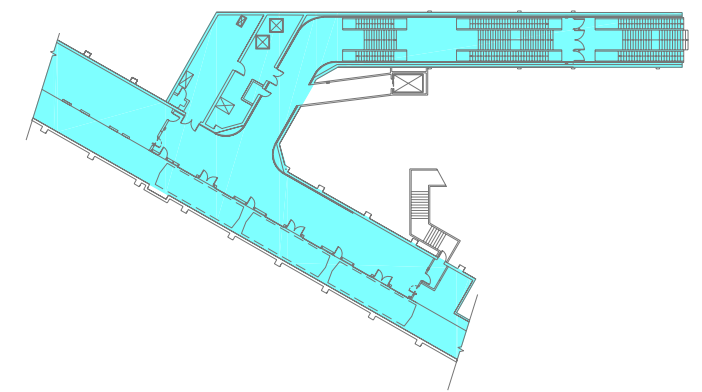
Figure 3

Port of Seattle
SEA-TAC INTERNATIONAL AIRPORT
PROJECT: **ACM FIREPROOFING LOCATION DRAWING**
SHEET TITLE: **MAIN TERMINAL - CONCOURSE B - STS, RAMP & CONCOURSE LEVELS**

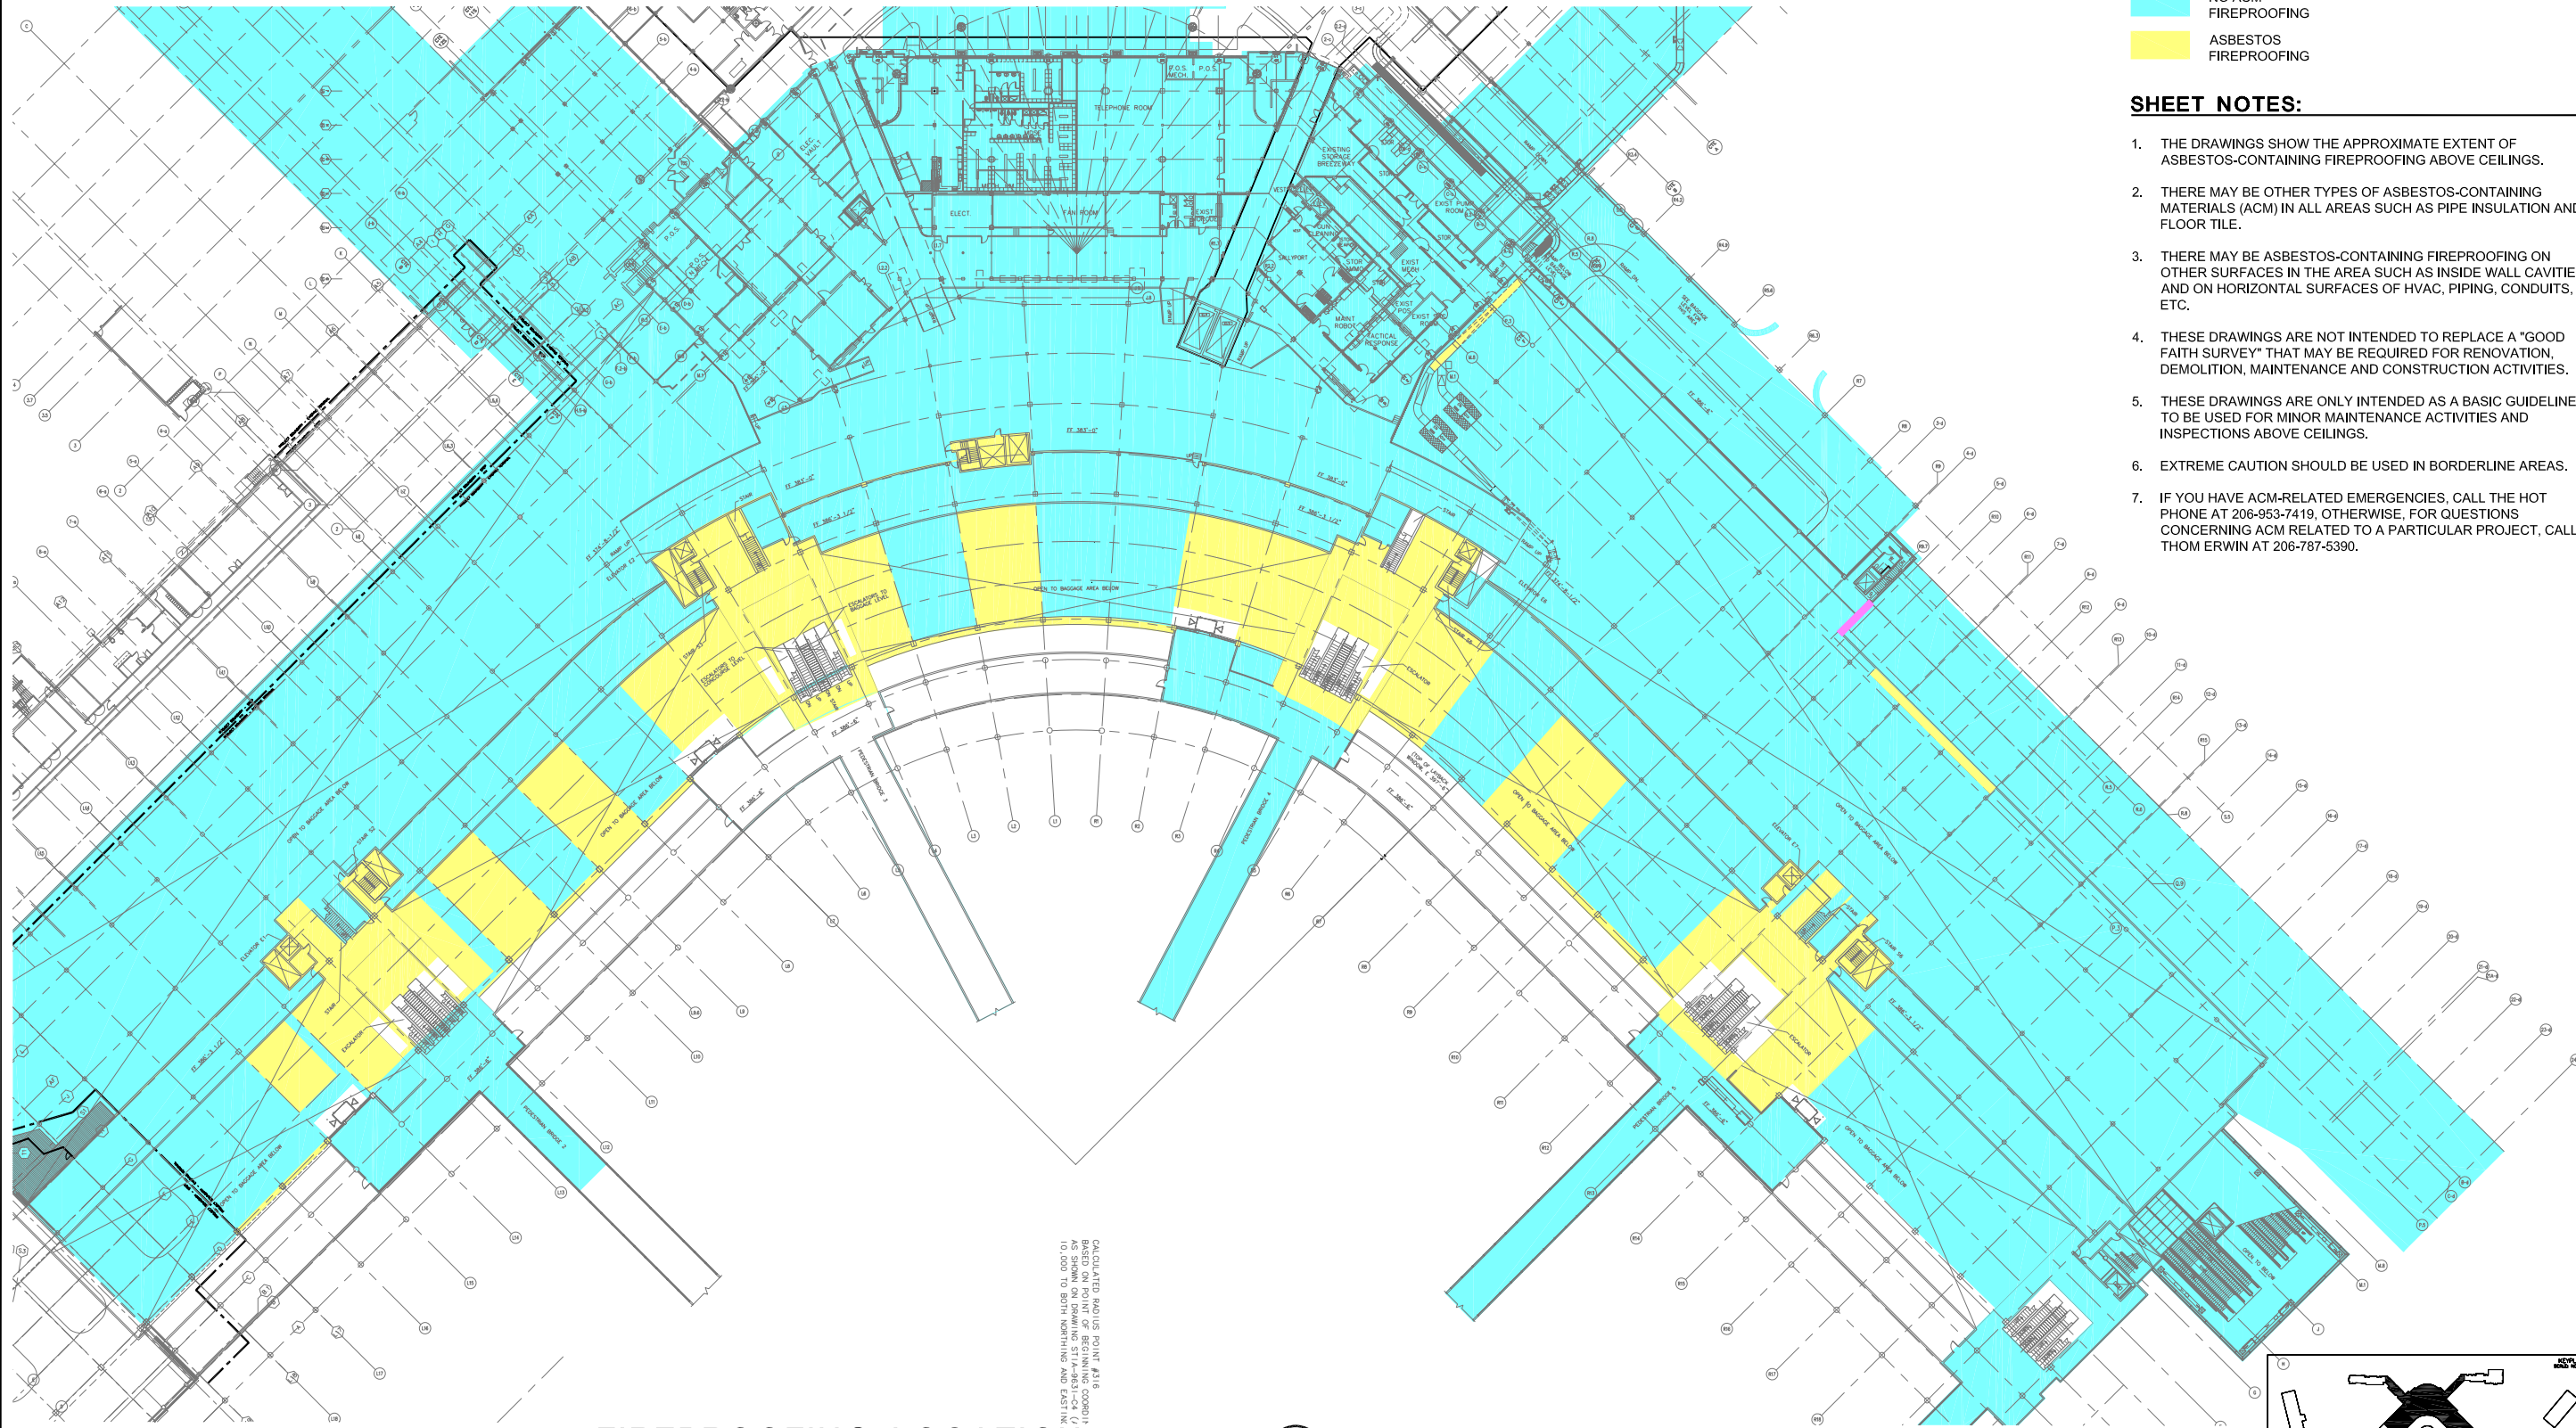
Figure 4

Port of Seattle
 SEA-TAC INTERNATIONAL AIRPORT
 PROJECT: **ACM FIREPROOFING LOCATION DRAWING**
 SHEET TITLE: **MAIN TERMINAL BRIDGE & RAMP LEVEL**
