Limited Good Faith Survey

September 11, 2023

Post-IAF Airline Realignment (N00030)

Seattle-Tacoma International Airport – North Satellite

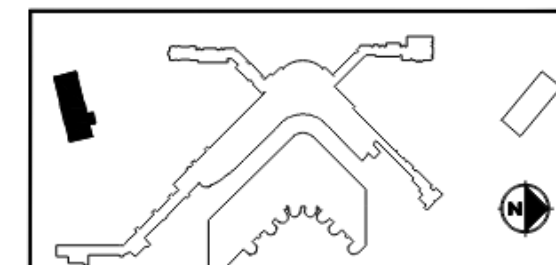
Figure 2
South Satellite Ramp Level
Asbestos Material Locations – Fireproofing

Material	Material Location	Asbestos Content
South Satellite Ramp Level		
Fireproofing overspray and debris	Wall cavities in South Satellite work area See Figure 2	PACM
Block filler sealant	CMU walls in South Satellite work area See Figure 1	PACM

RESIDUAL ASBESTOS-CONTAINING FIREPROOFING WAS FOUND AT THIS APPROXIMATE LOCATION ASSOCIATED WITH NON-ACM SEALANT ON METAL DUCTING BEHIND NON-ACM DUCT INSULATION (DUCTING IS NEAR CEILING)
 (DUCTING IS NEAR CEILING)
 SEE SAMPLE ID: SSHVAC-R21-01
